**DEPARTMENT OF TRANSPORTATION**

Office of Structural Materials

Contract #: 04-0120F4Cty: SF/ALA Rte: 80 PM: 13.2/13.9File #: 69.28**WELDING INSPECTION REPORT****Resident Engineer:**Siegenthaler, Peter**Address:** 333 Burma Road**City:** Oakland, CA 94607**Report No:** WIR-019706**Date Inspected:** 08-Jan-2011**Project Name:** SAS Superstructure**OSM Arrival Time:** 700**Prime Contractor:** American Bridge/Fluor Enterprises, a JV**OSM Departure Time:** 1900**Contractor:** Zhenhua Port Machinery Company, Ltd (ZPMC), Changxing Island **Location:** Shanghai, China**CWI Name:** Xu Le Feng**CWI Present:** Yes No**Inspected CWI report:** Yes No N/A**Rod Oven in Use:** Yes No N/A**Electrode to specification:** Yes No N/A**Weld Procedures Followed:** Yes No N/A**Qualified Welders:** Yes No N/A**Verified Joint Fit-up:** Yes No N/A**Approved Drawings:** Yes No N/A**Approved WPS:** Yes No N/A**Delayed / Cancelled:** Yes No N/A**Bridge No:** 34-0006**Component:** OBG Components**Summary of Items Observed:**

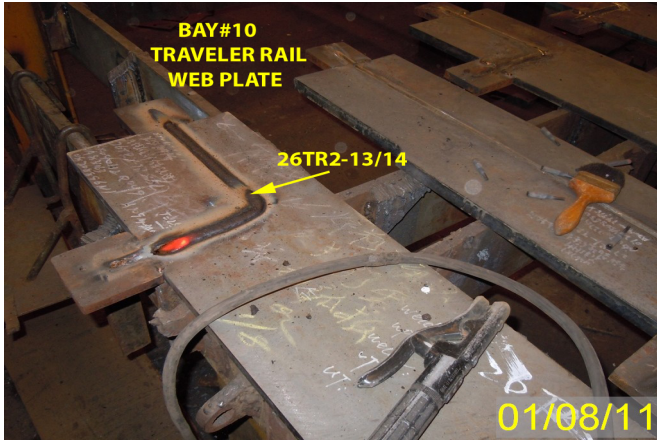
Weld joint # 13 located on Traveler rail web plate 26TR2. Welder is identified as 040581. ZPMC Quality Control (QC) Inspector is identified as Jiang Xiao Bo. The welding variables recorded by QC appeared to comply with the WPS – B – T – 2111 – B – U2. (See attached photo)
